Watervliet Arsenal
Officers' Quarters
(Quarters 4)
Mordecai Drive west of Mettler Road
Watervliet
Albany County
New York

HABS No. NY-5521D

WATERVLIET ARSENAL
OFFICERS' QUARTERS
(Quarters 4)

Significance: The building is an intact integral element of the officers' family housing area developed at the north side of the arsenal during the nineteenth century to house the installation's highest ranking officers.

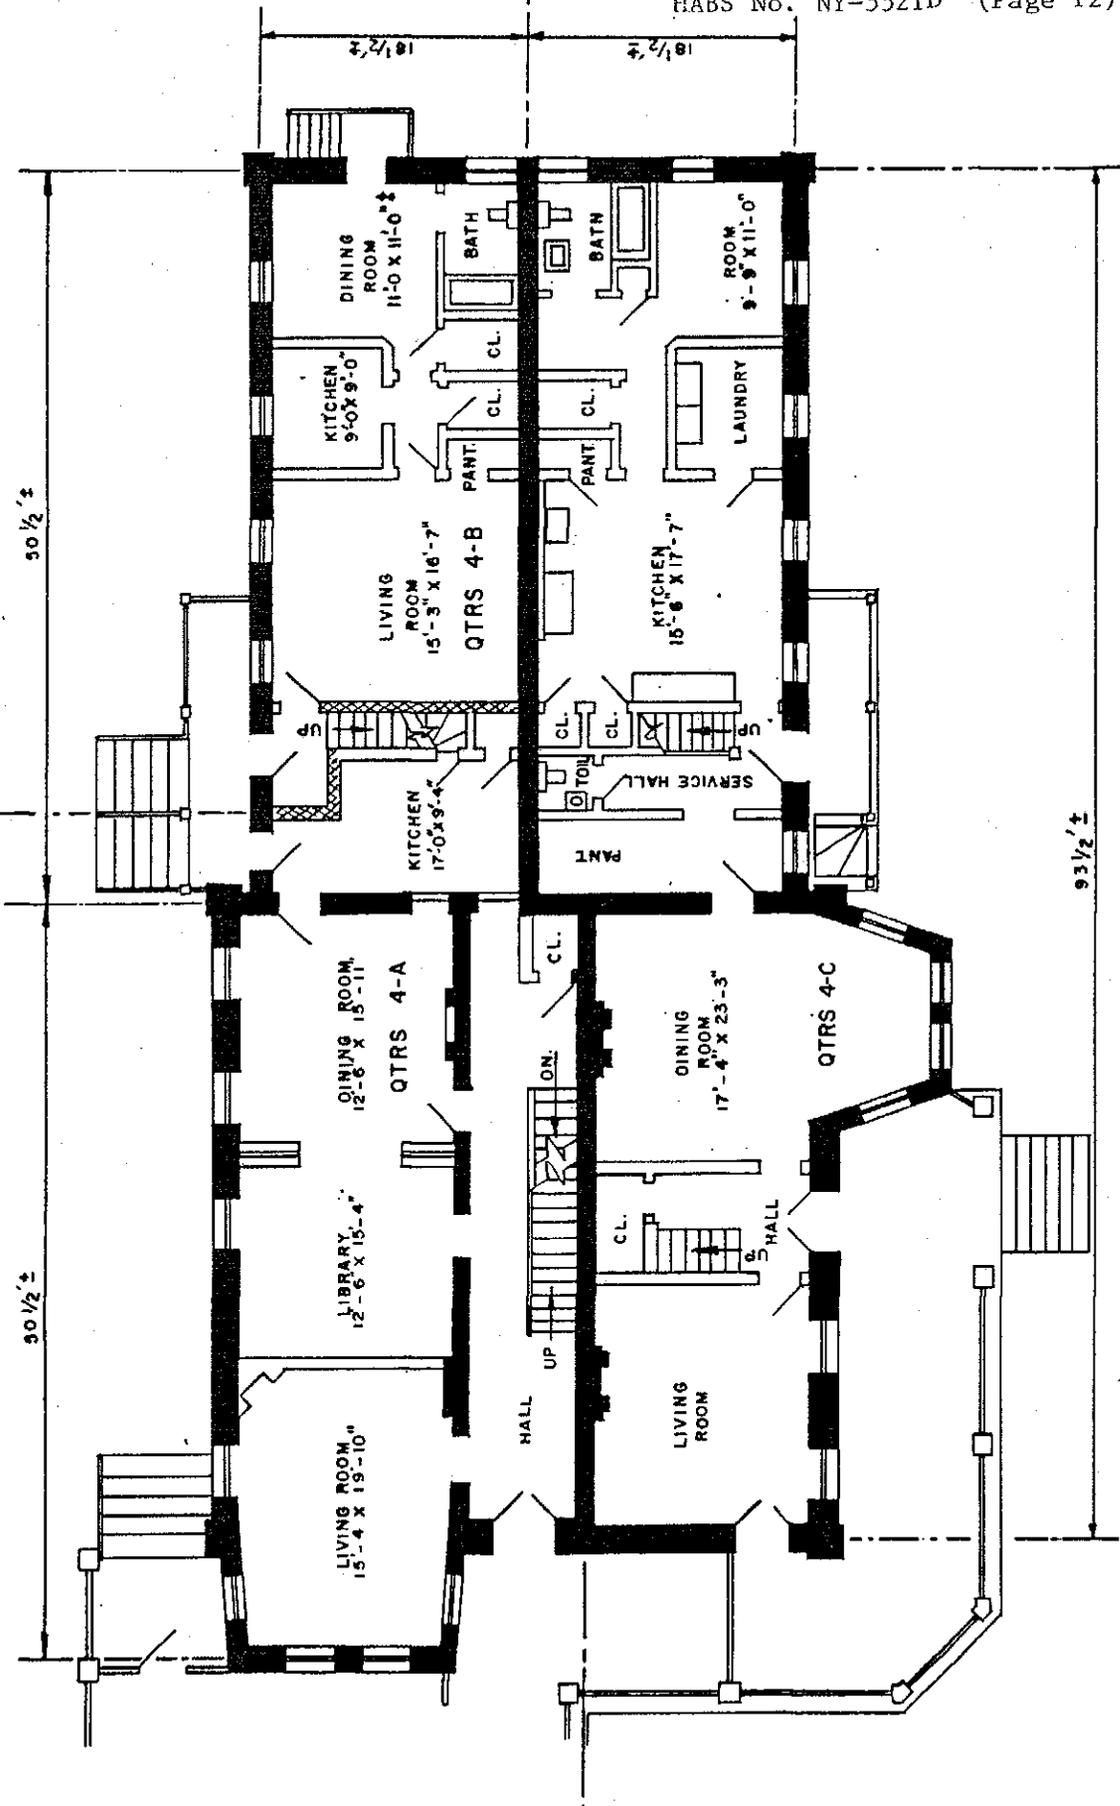
FIRST FLOOR PLAN
OFFICERS' QUARTERS
BUILDING NO. 4

QUARTERS 4 A

QUARTERS 4 C

NET FLOOR AREA
6910
Square feet
FLOOR CAPACITY
Per square foot

essentially mirror images. The plan was published in Officers' Quarters at the Arsenals and Armory, a copy of which is in the collection of the Watervliet Arsenal Museum.
